Long-Term Surveillance and Maintenance Program

2003 Annual Site Inspection and Monitoring Compliance Report for Uranium Mill Tailings Radiation Control Act Title II Disposal Sites

November 2003

**Bluewater, New Mexico
Edgemont, South Dakota
Sherwood, Washington**

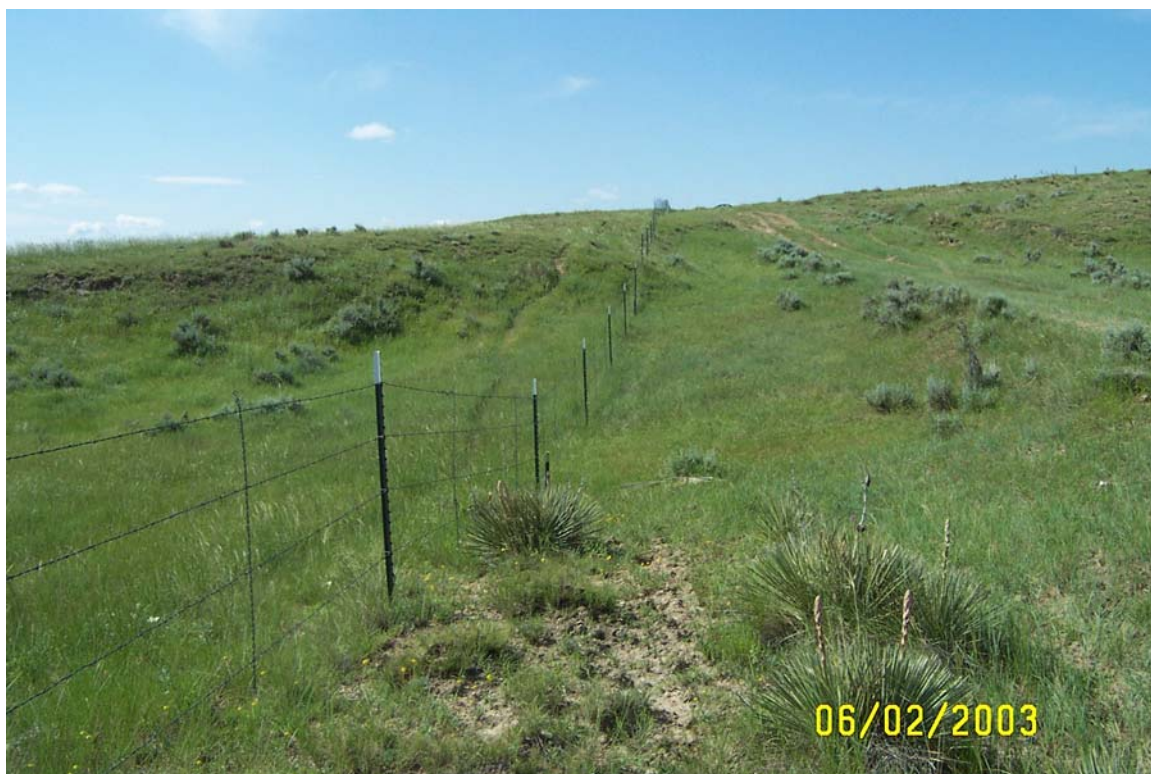
A four-strand barbed-wire fence was installed in spring 1999 along the site boundary to demarcate DOE property and to control grazing on the property. The entire fence line was walked to inspect the fence and the boundary monuments. Minor fence repairs, including tightening two strands of wire on the west boundary and reattaching wire to the t-posts, were conducted during the inspection. Based on the condition of the range inside the fence on site property versus outside the fence, the fence is adequately preventing unauthorized grazing. The fence is in excellent condition (PL-1).

EDG 6/2003. PL-1. Fence line on western property boundary. NOTE: Correct date of photo is 06/04/2003.

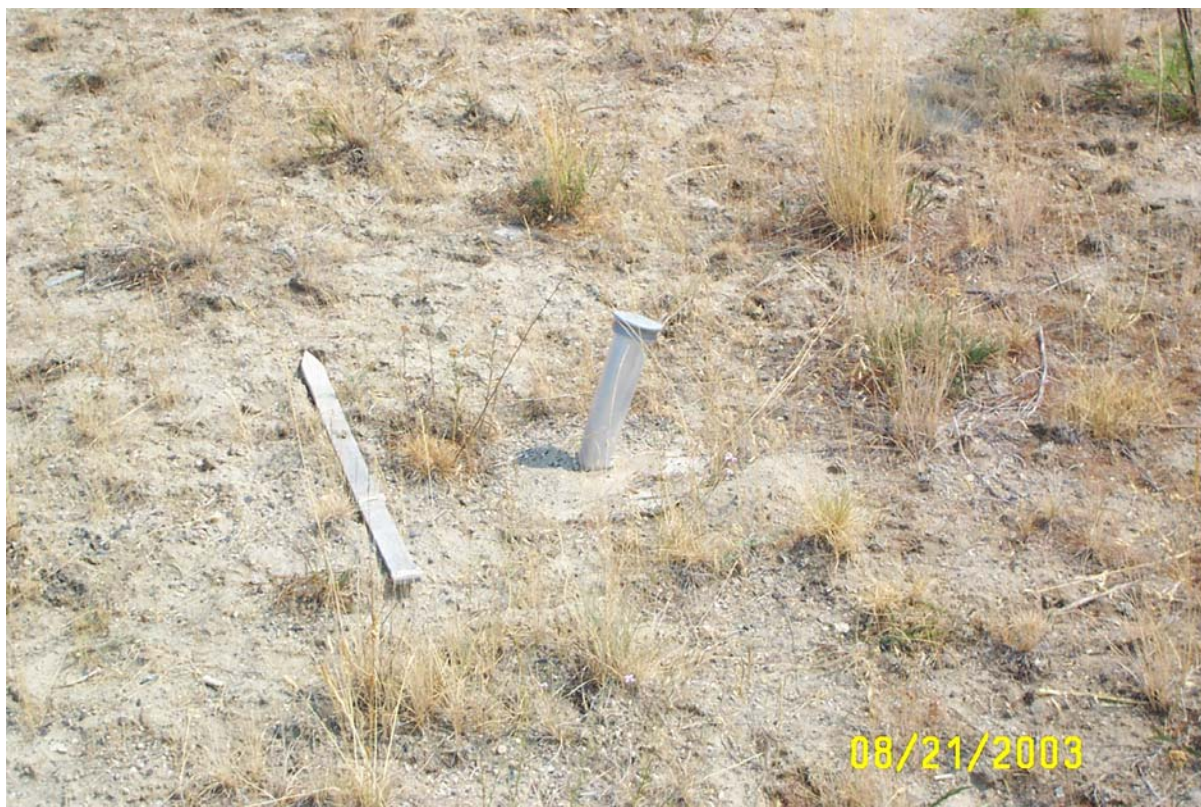
Six boundary monuments designated BM–1, BM–2, BM–3, BM–3A, BM–4, and BM–5 define the site boundary. Inspectors noted that BM–3A had been bent (PL–1); all other monuments were in excellent condition.

SHE 8/2003. PL-1. Boundary monument 3A, bent.

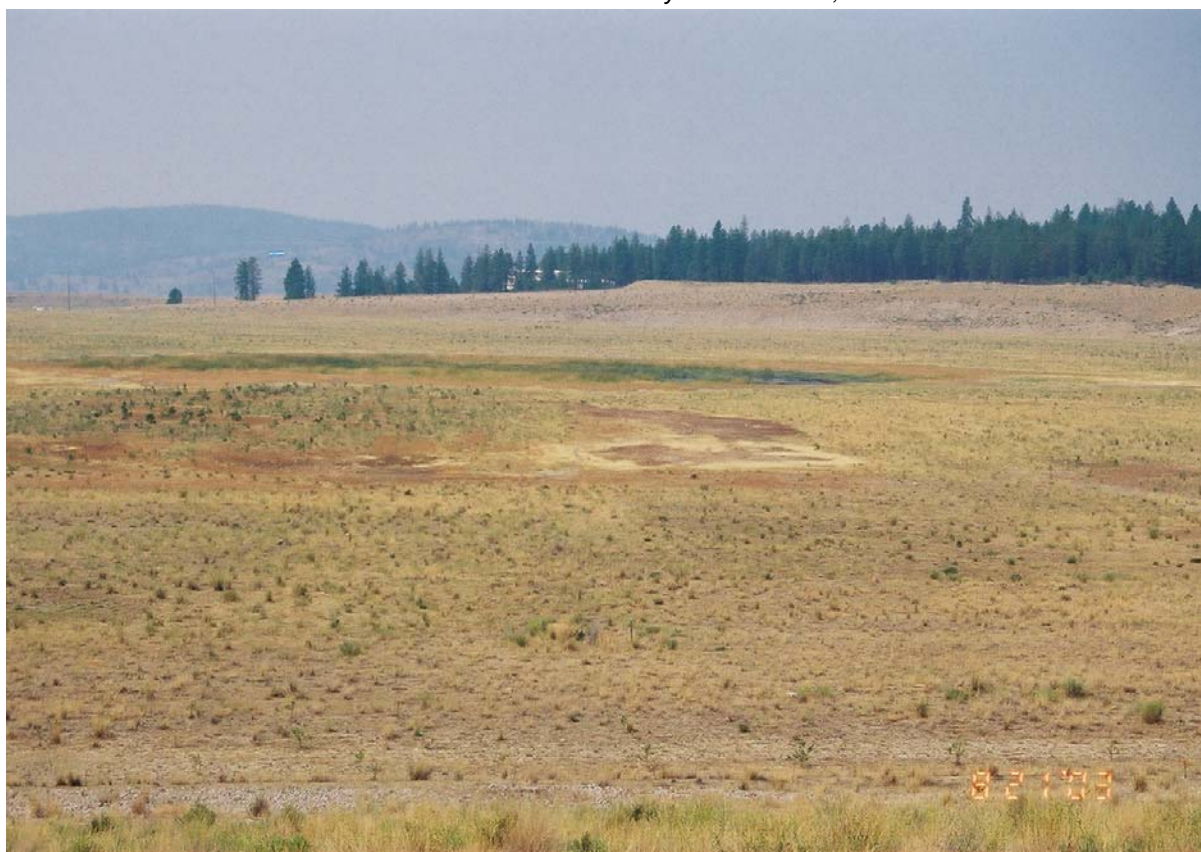
Inspectors noted an additional settlement area east of the existing pond area (PL–2). This low-lying area, 3 to 5 acres in size, contains riparian vegetation and shows indications of having saturated soils during certain times of the year. There was no water in this settled area at the time of the inspection.

SHE 8/2003. PL-2. Additional settlement area on top of tailings impoundment; pond area (dark green) is in background.

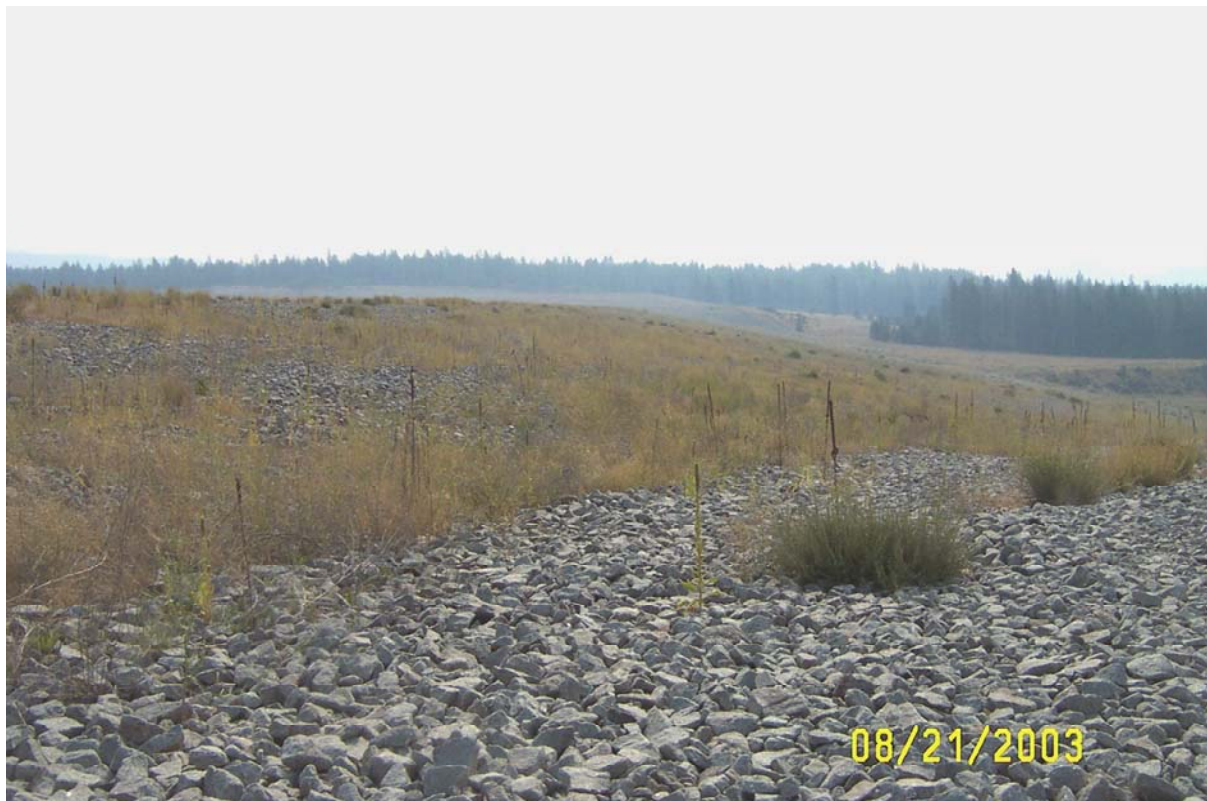
The tailings embankment on this site, classified as a dam, necessitates a dam safety inspection to assure continued compliance with the Federal Dam Safety Act. The impoundment dam face was inspected in accordance with the attached Dam Inspection Checklist and photographed (PL–4 and PL–5). No evidence of seepage, slumping, erosion, or instability was observed. Ponderosa pines, some as tall as 24 inches, were observed on the face.

SHE 8/2003. PL-4. Embankment face showing vegetation encroachment.

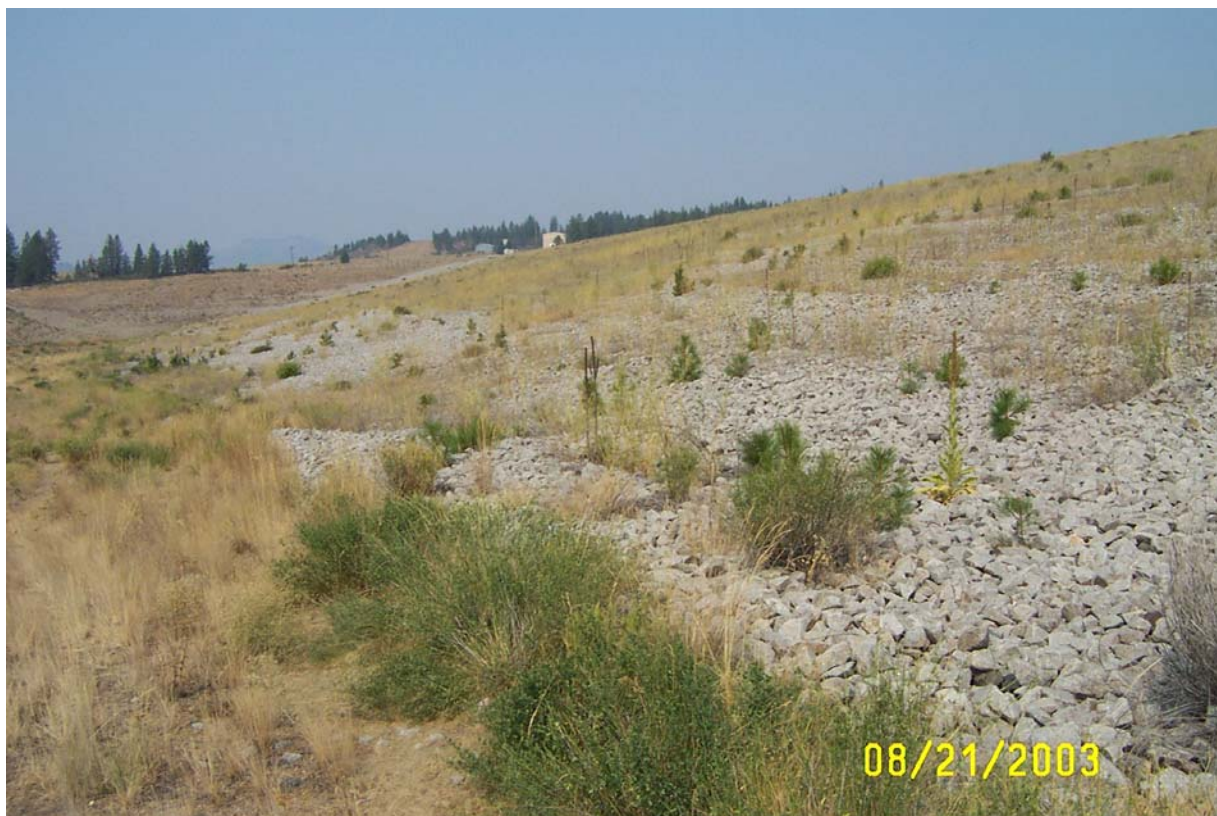
SHE 8/2003. PL-5. Embankment face showing vegetation encroachment.

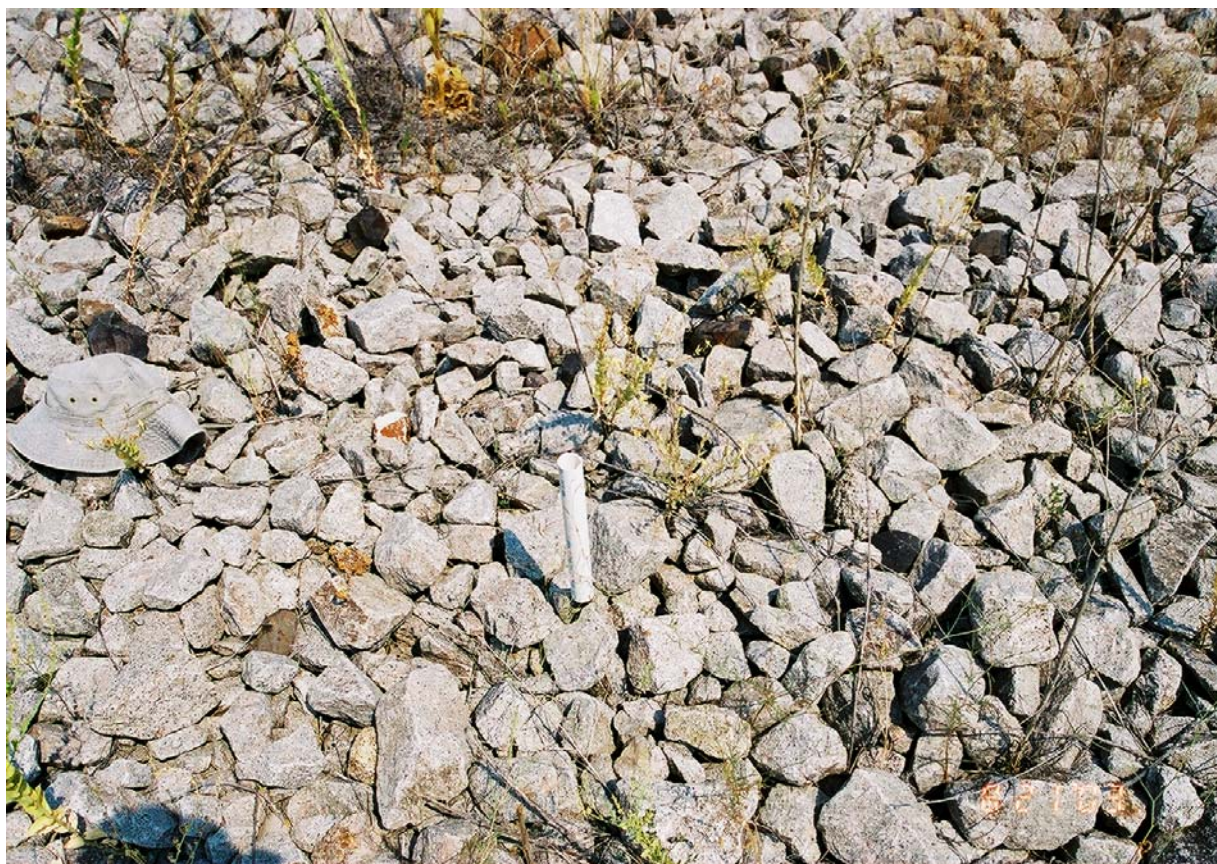
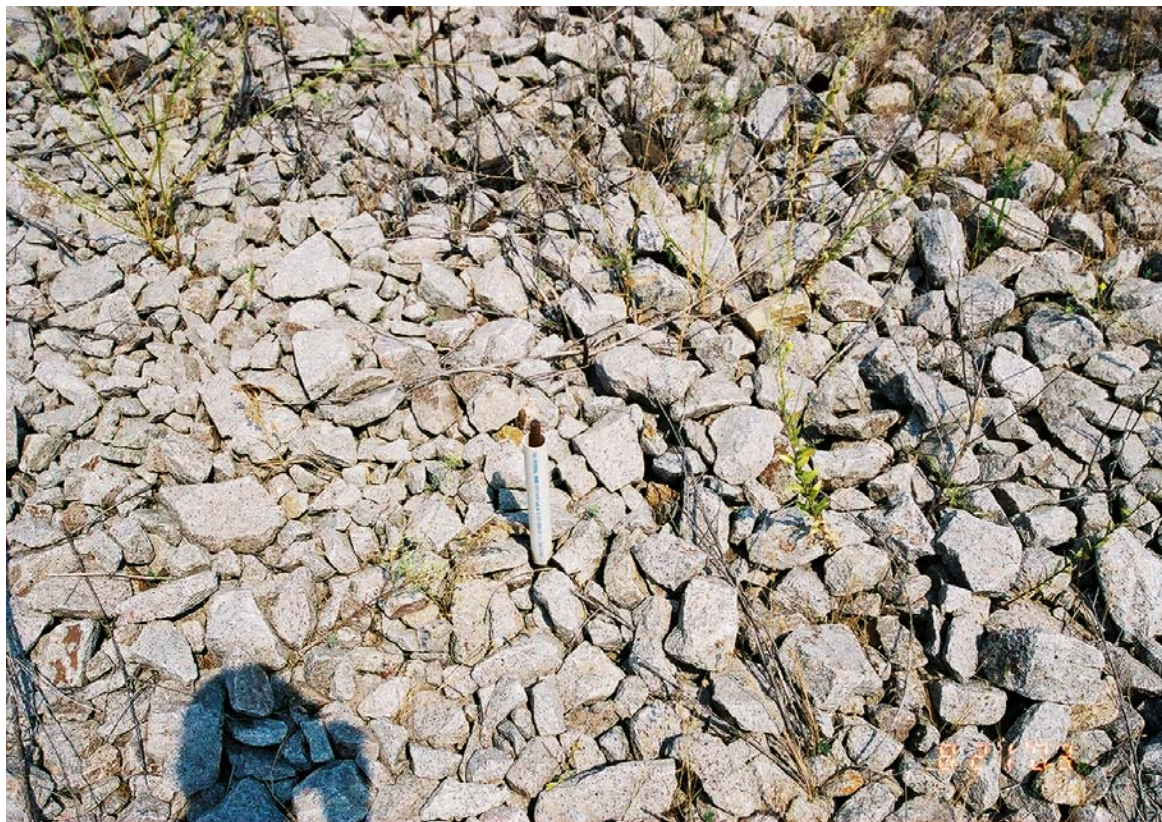
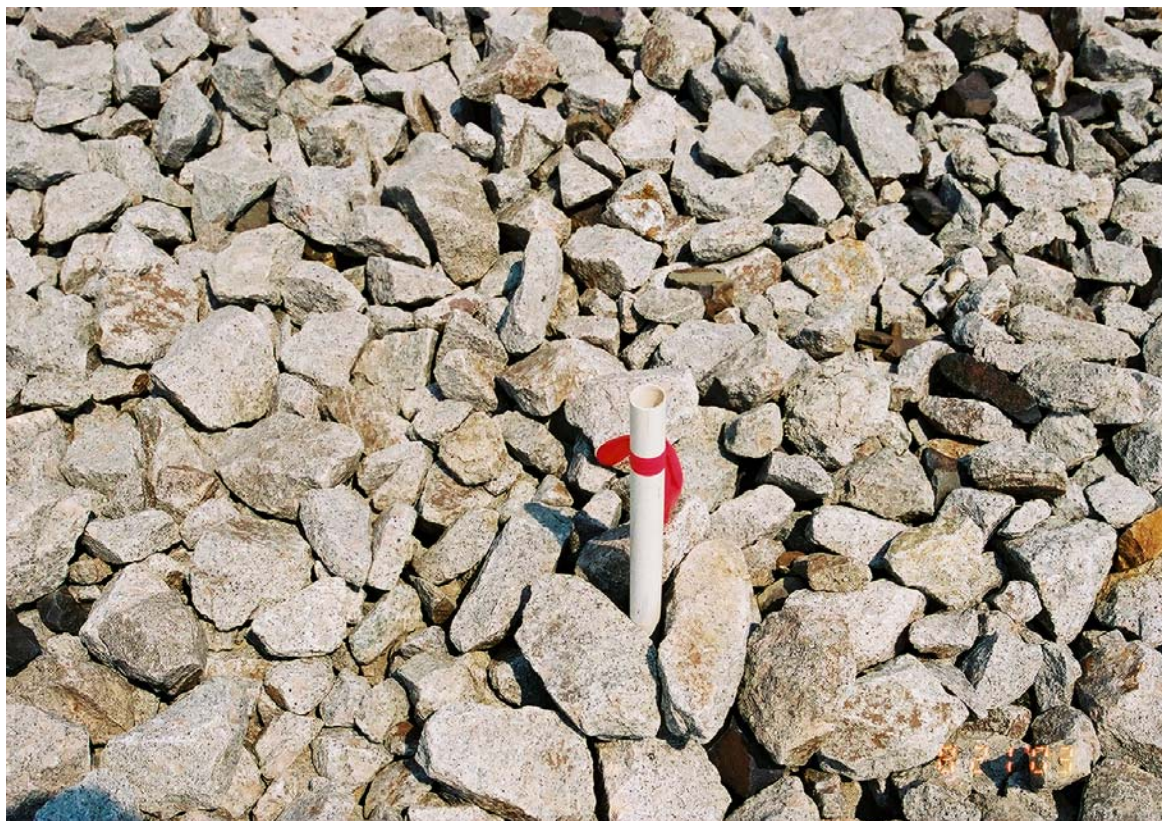
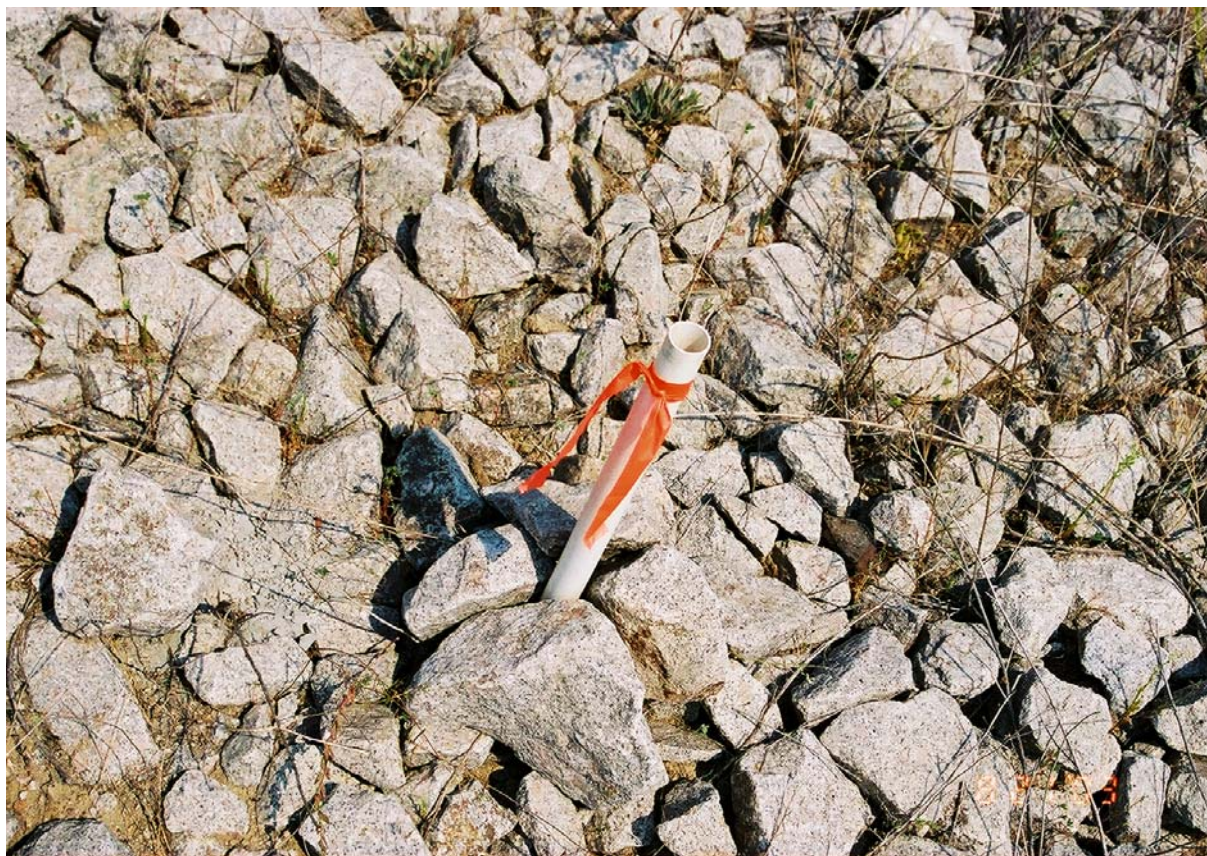
with a sleeve of PVC pipe or a section of PVC pipe at the center of each plot and obtained location information using global positioning system equipment. Baseline photographs were taken of each plot (facing a northerly direction) (PL-6 through PL-9). Photography should be repeated during future inspections for comparison to baseline rock quality. Future inspectors may recommend changes to the plot inspection frequency or cessation of monitoring.

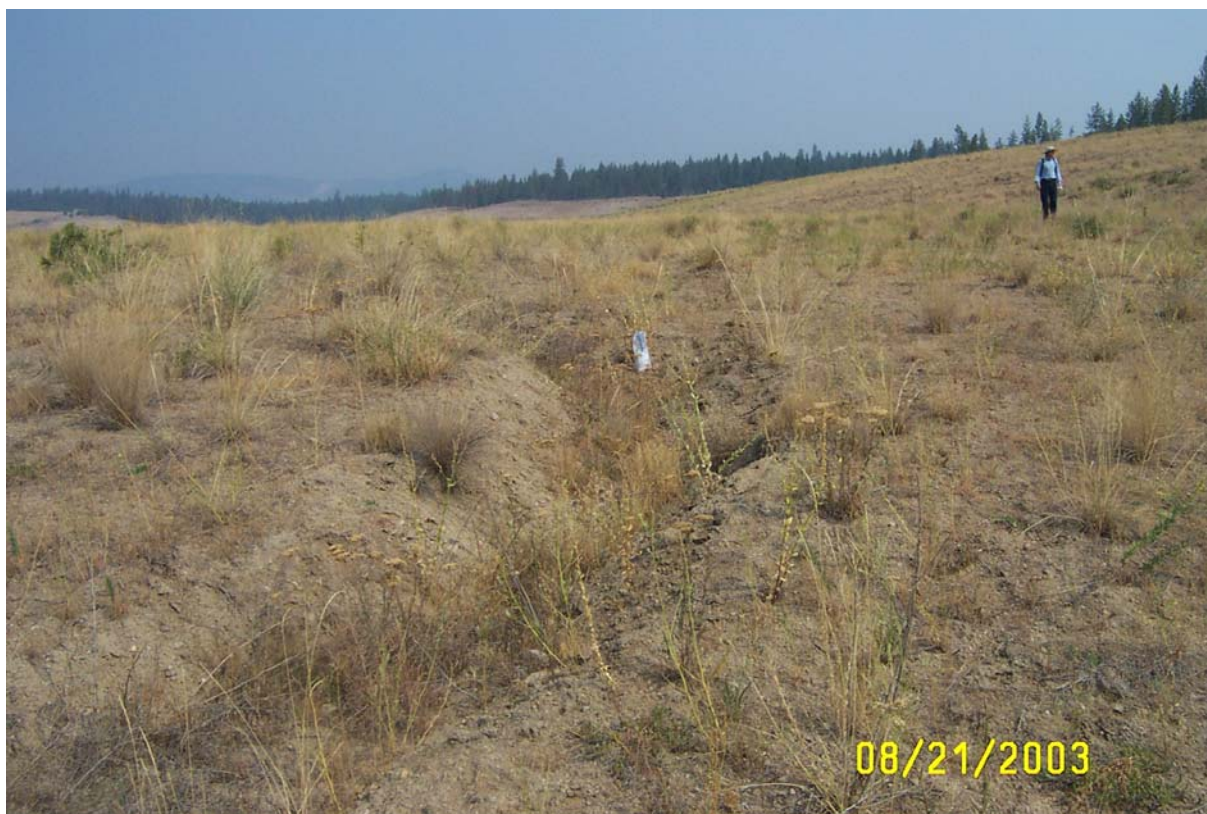
Adjacent to the eastern end of the dam face is a steep slope that is underlain by rock and covered with soil. Numerous rills and gullies noted during previous annual inspections were inspected on this slope (PL-10 through PL-13). No new rills were identified, and the size of existing rills had not increased since the 2001 and 2002 inspections. Although these erosional features do not threaten site integrity, they should be inspected annually to ensure the slope remains stable and sediment is not transported offsite.

SHE 8/2003. PL-10. Gully north of east end of embankment face.

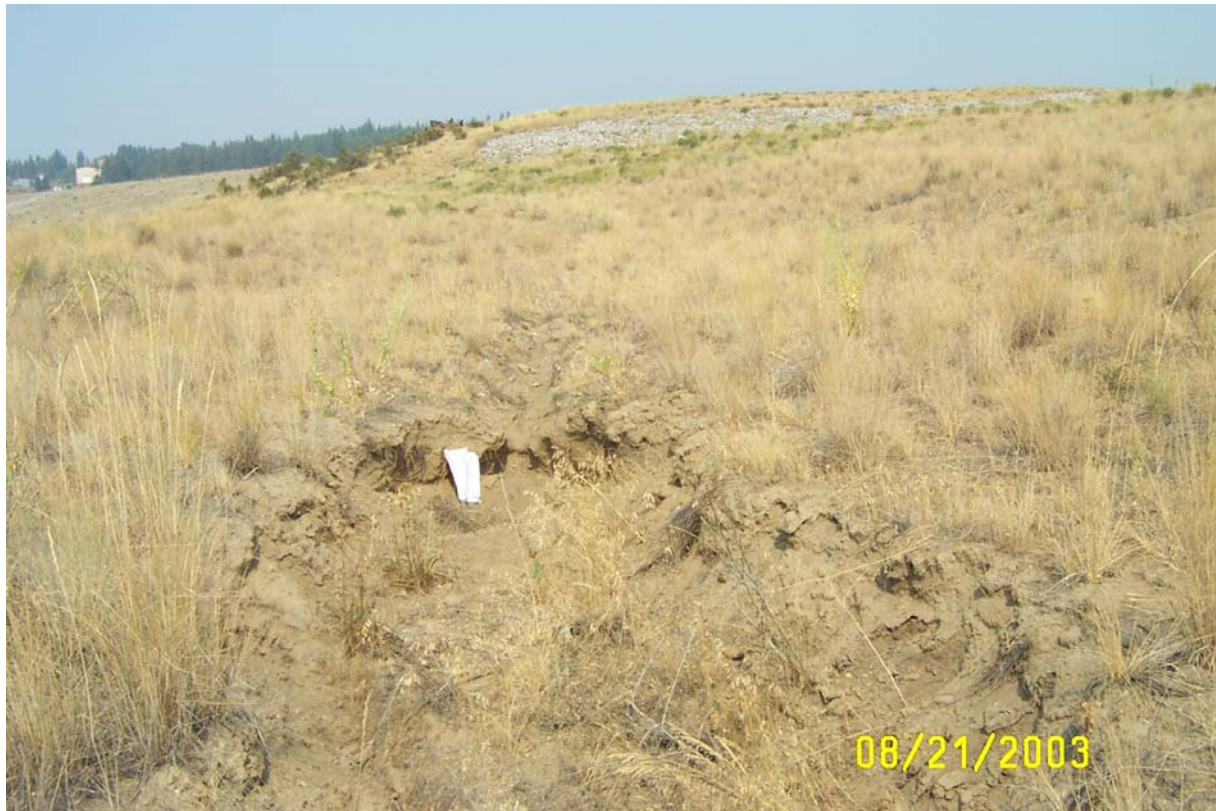
SHE 8/2003. PL-11. Gully and headcut below riprap-armored portion of swale east of embankment face.

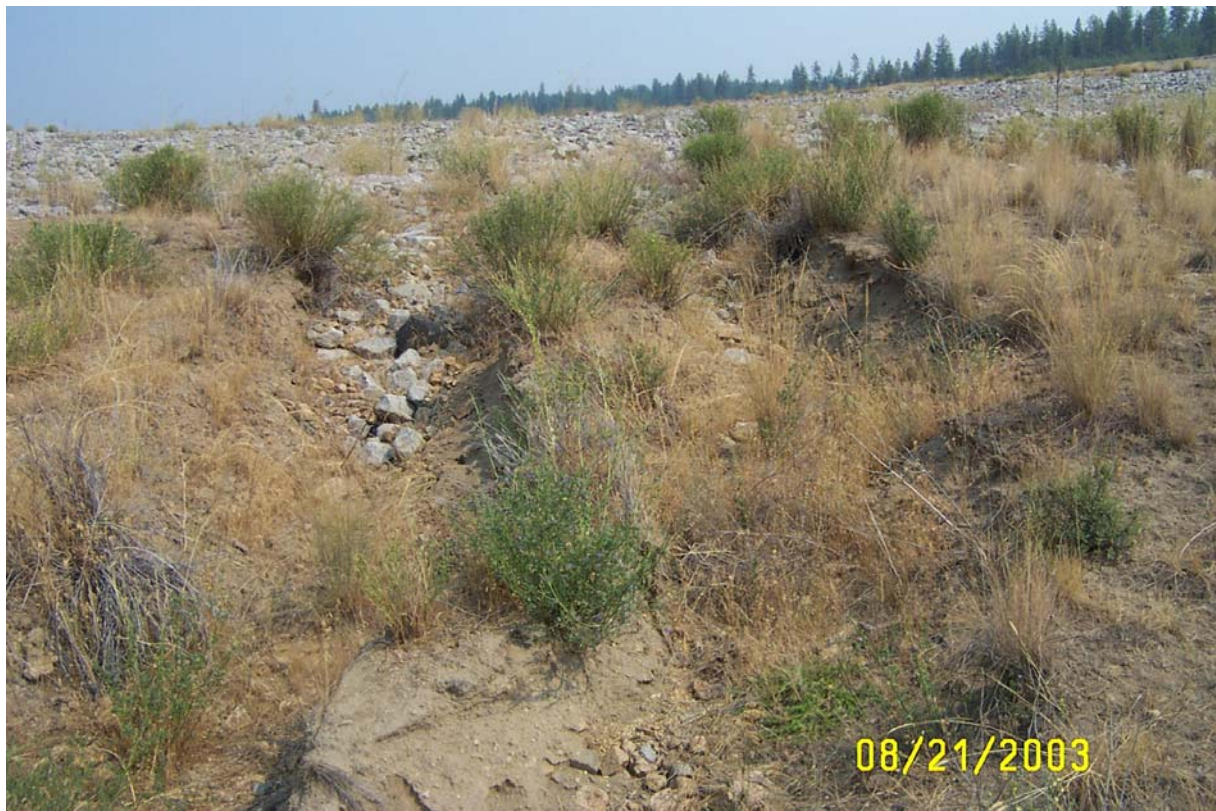
SHE 8/2003. PL-12. Gully below riprap-armored portion of swale east of embankment face.

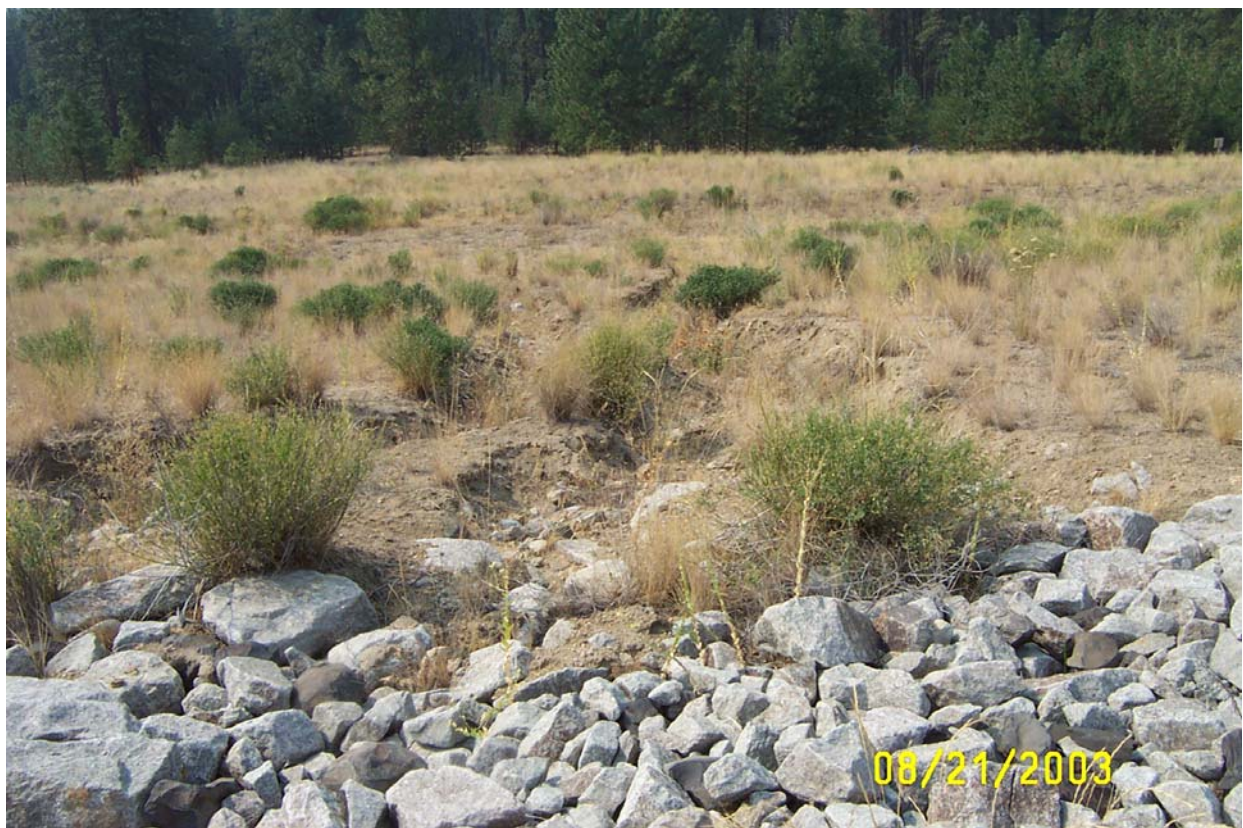
SHE 8/2003. PL-13. Gully below riprap-armored portion of swale east of embankment face.

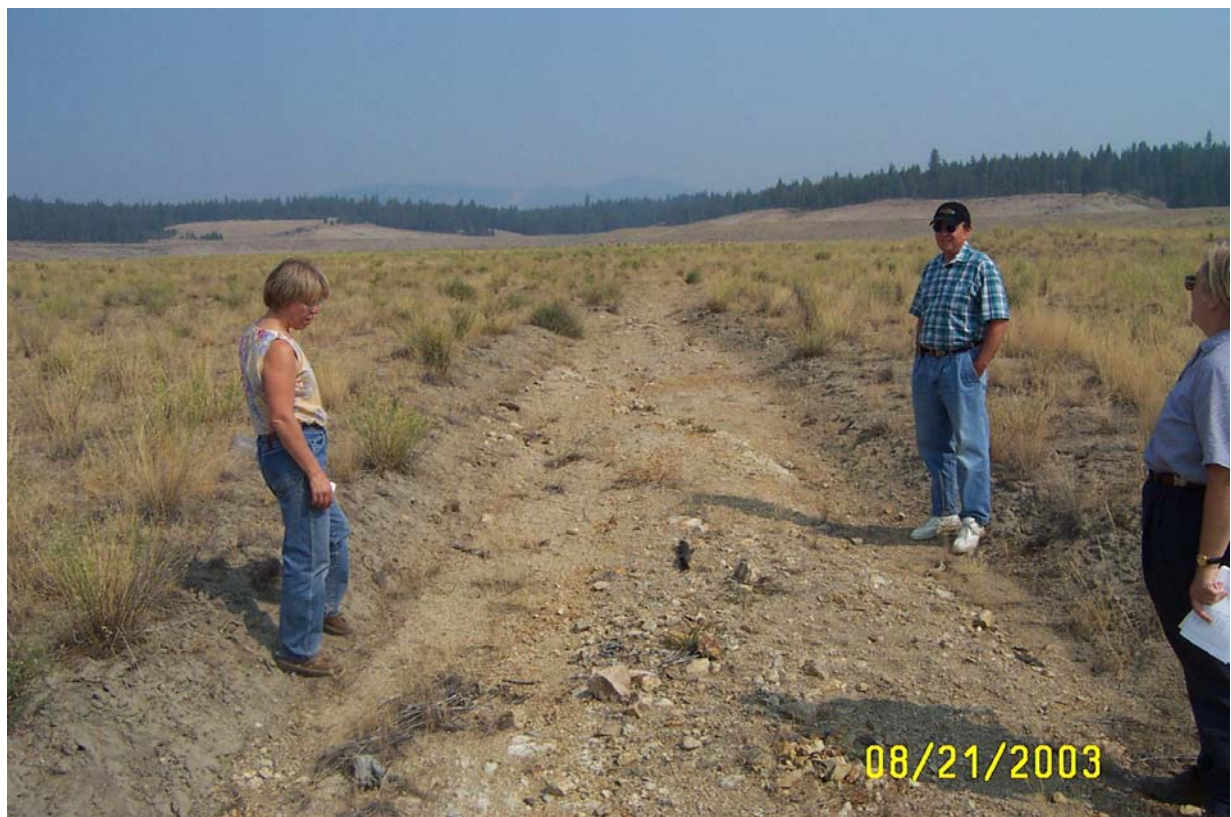
A swale across the south end of the top slope is armored with riprap at the east end of the embankment, where the gradient increases. Erosion noted previously north of the riprap has cut to bedrock but considering the resistant material exposed at the invert and the low gradient of the unarmored portion of the swale, the swale appears stable (PL-14). Although additional erosion is unlikely, inspectors should monitor this area for changes.

SHE 08/2003. PL-14. Swale at top of east end of embankment showing erosion to bedrock.
